## Certified ISO 9001:2015 Quality Management System

# EXAMINATION OF HIGH MAST LIGHT POLES

## PREVENTION OF CATASTROPHIC STRUCTURAL FAILURE OF HIGH MAST POLES IN THE INTEREST OF PUBLIC SAFETY

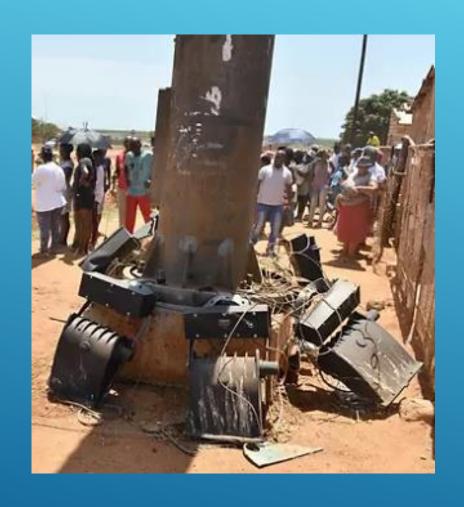
### High-Mast Light in Soshanguve after its lighting ring fell

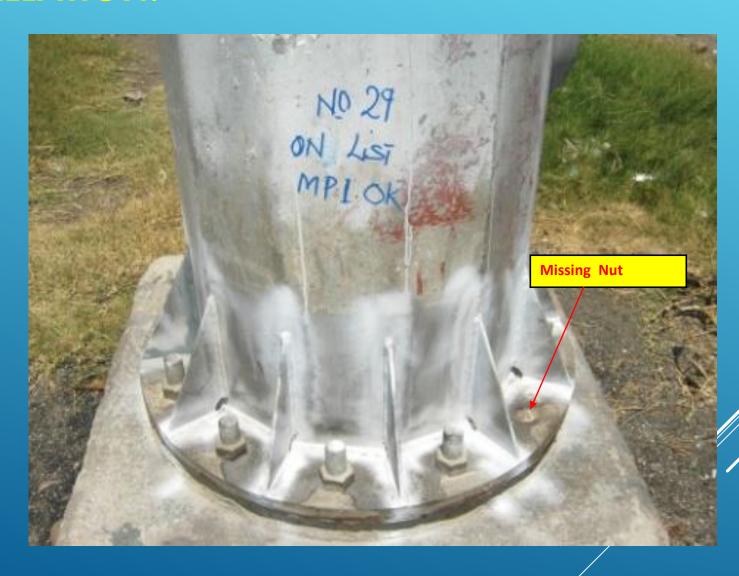
## ANCHOR STUD OVER TORQUED DURING INSTALLATION.

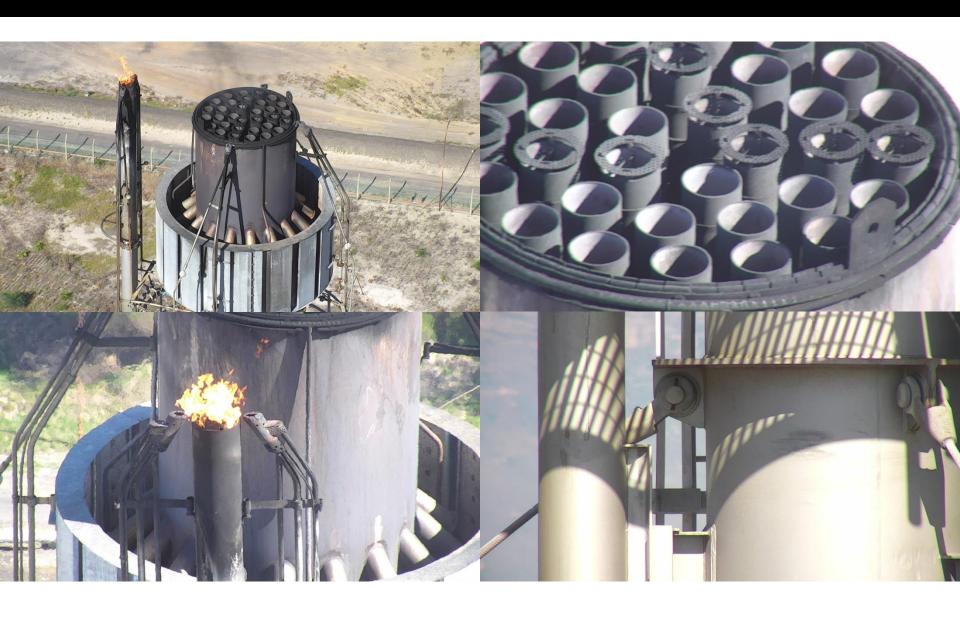
## VISUAL INSPECTION - FLARE STACK

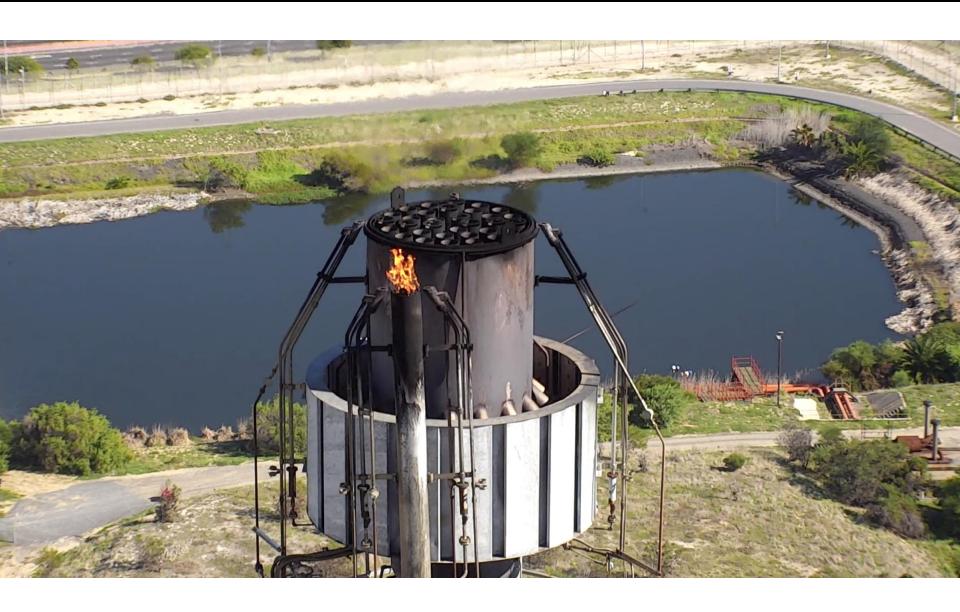
## VISUAL INSPECTION - FLARE STACK

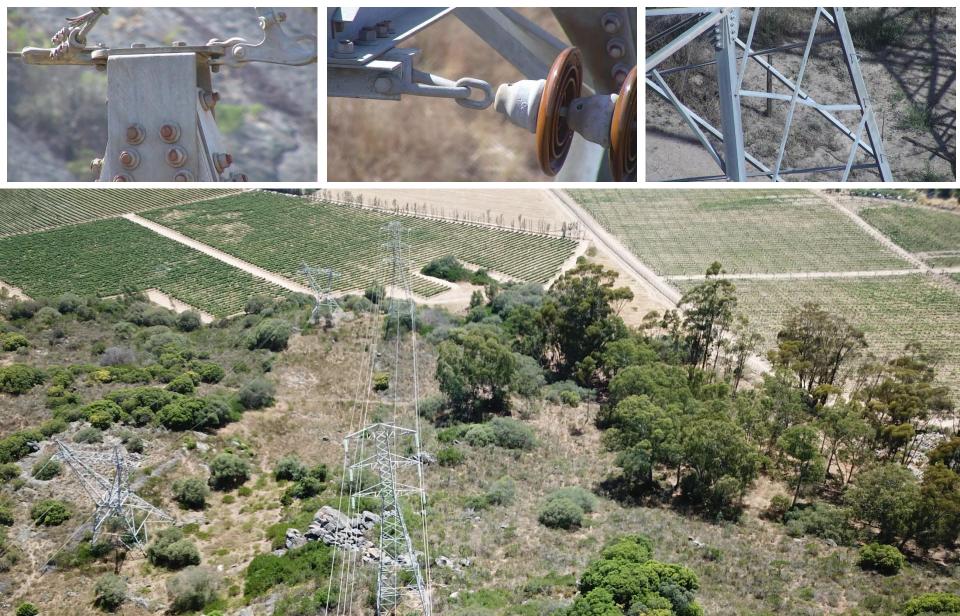
## VISUAL INSPECTION - TRANSMISSION LINES

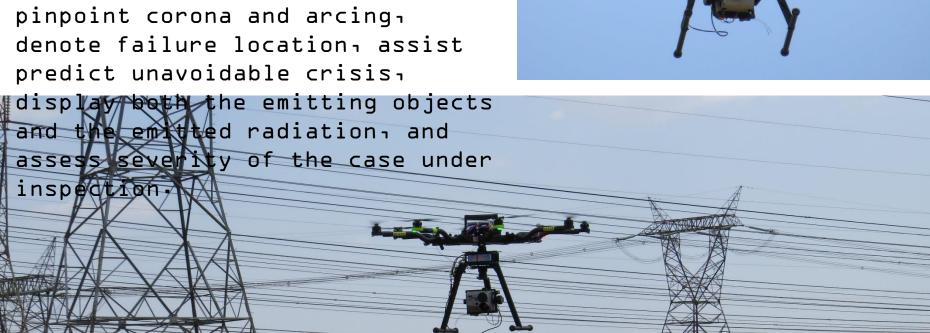
### UV INSPECTION - POWERLINES

UV inspection technology is being used for predictive maintenance of high voltage equipment together with IR-thermography and ultrasonic devices. The value added by UV inspection is reflected in its ability to pinpoint corona and arcingadenote failure locational assist predict unavoidable crisisa

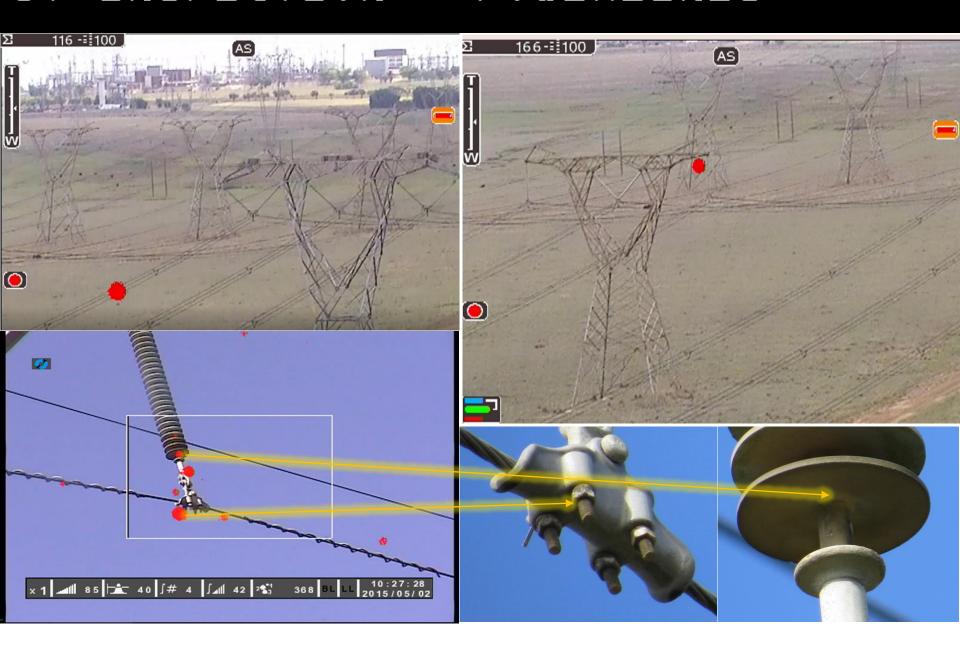
## UV INSPECTION - POWERLINES

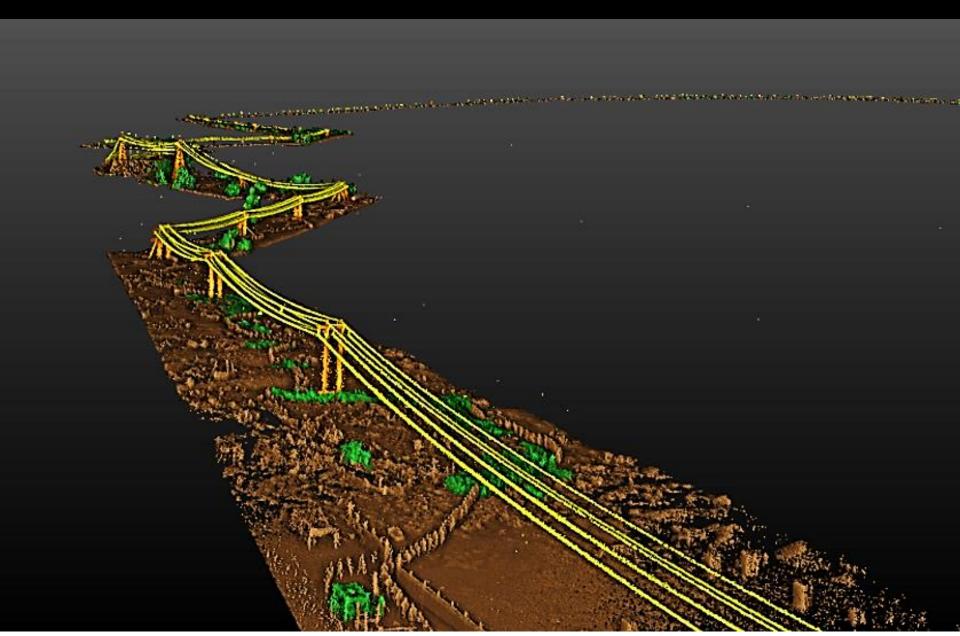
## LIDAR RESULTS - POWERLINES

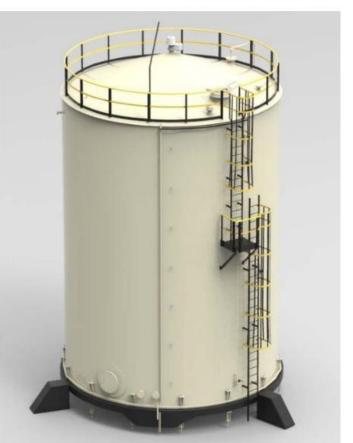
## LIDAR RESULTS

#### **Tank Surface Area Calculations**

Description	Colour	Area (SQM)
Vessel, Nozzles + Brackets	Beige	353.8
Concrete Support Structure	Black	98.2
Handrails + Ladders	Yellow	10.1
Handrails + Ladders	Black	29.4
Miscellaneous	Black	1.4
Utilities	Orange	0.3
Utilities	Grey	0.8
	Total	494.0

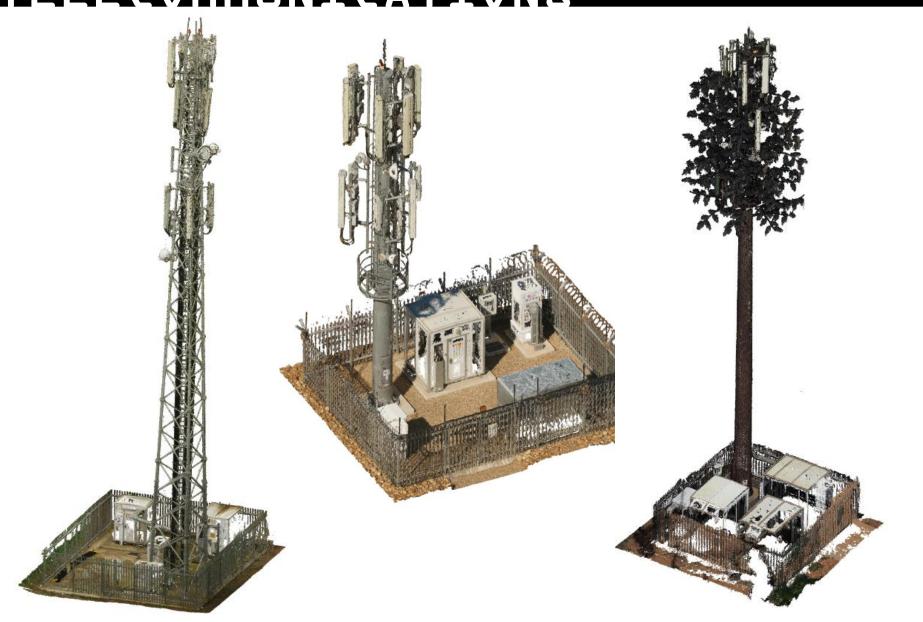
# 3D MODELING TELECOMMUNICATIONS
